*NIST Technical Note 1500-10*  
*Materials Reliability Series*

# Weld Repair of the U.S. Capitol Dome

A Report to the Office of the Architect of the Capitol on Project  
900265 K

December 2002

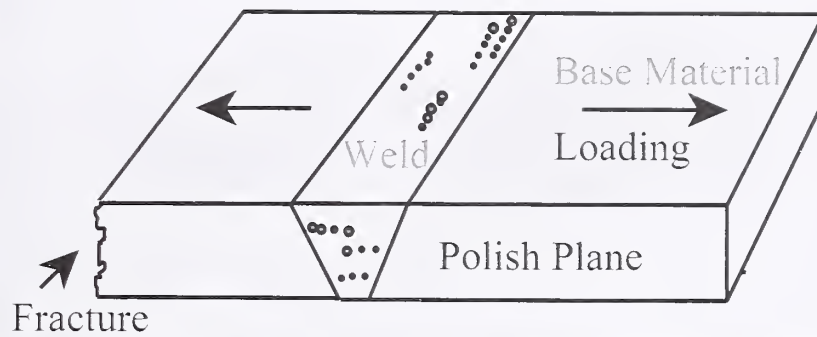
Figure 1. Joint K showing the fracture location in the casting, and the small pores found in the weld.

**Spray powder K:** Under tensile testing, both welds fractured in the base material, well away from the weld (as shown in Figure 1) indicating that the weld was stronger than the casting and

the HAZ was not the critical fracture location. Once again, the HAZ was free from crack starters and unacceptably high residual stresses. The tensile strengths of the two welds were 49 and 91 MPa (7 and 13 ksi). Again, these strengths suggest that the dome might be best characterized as a Grade 10 casting. The regions in the casting adjacent to welds J and K have a HAZ that is about 2 mm thick. The first 0.5 mm nearest the fusion boundary has a high fraction of martensite, a brittle phase formed in iron castings from the heat of the welding process. This phase should be controlled by minimizing the time and temperature of the welding process. As shown in Figure 2, the graphite flakes exhibit a combination of type A and type B morphology right up to the fusion line where the filler metal begins. The exception was in the root of the weld, where there was less of the type A structure and more of a brittle martensite phase in the HAZ of the weld. The weld has numerous pores, which tend to be arranged in linear or planar configurations (Figure 1) and are an artifact of the powder-spray technique. The level of porosity appears to be within an acceptable (and expected) range.

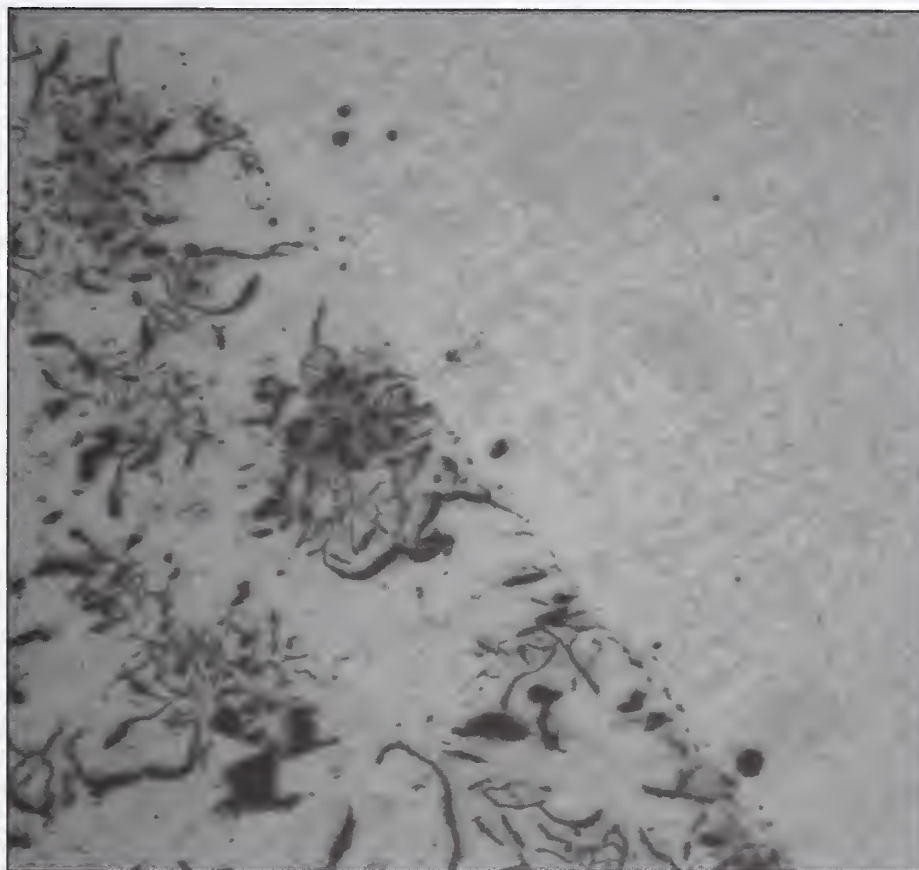
Figure 2. Micrograph of joint K (PA-7) showing the good fusion at the interface with the Dome cast iron. The powder spray deposit is at the upper right and the cast iron at the lower left.

The fusion zones at the interface are very similar for both welds J and K, as expected, since PA-7 was used at the interface of both welds. The interface is very nearly a straight line, the same boundary that was produced during the joint beveling operation just prior to welding. This means that the PA-7 never reached a temperature at which it melted the cast iron at the surface; however, the fusion bond is very good. The quality of this bond is substantiated by the fact that most of the transverse tensile tests failed far away from the weld or HAZ, and by the fact that we found that the PA-7 penetrated into cracks on the beveled surface. This penetration into the cast iron produced mechanical, as well as metallurgical bonding across the interface. In one case, J1, the failure traveled through a portion of the HAZ, but seemed to have originated at an imperfection on the surface, not as a result of this microstructure.

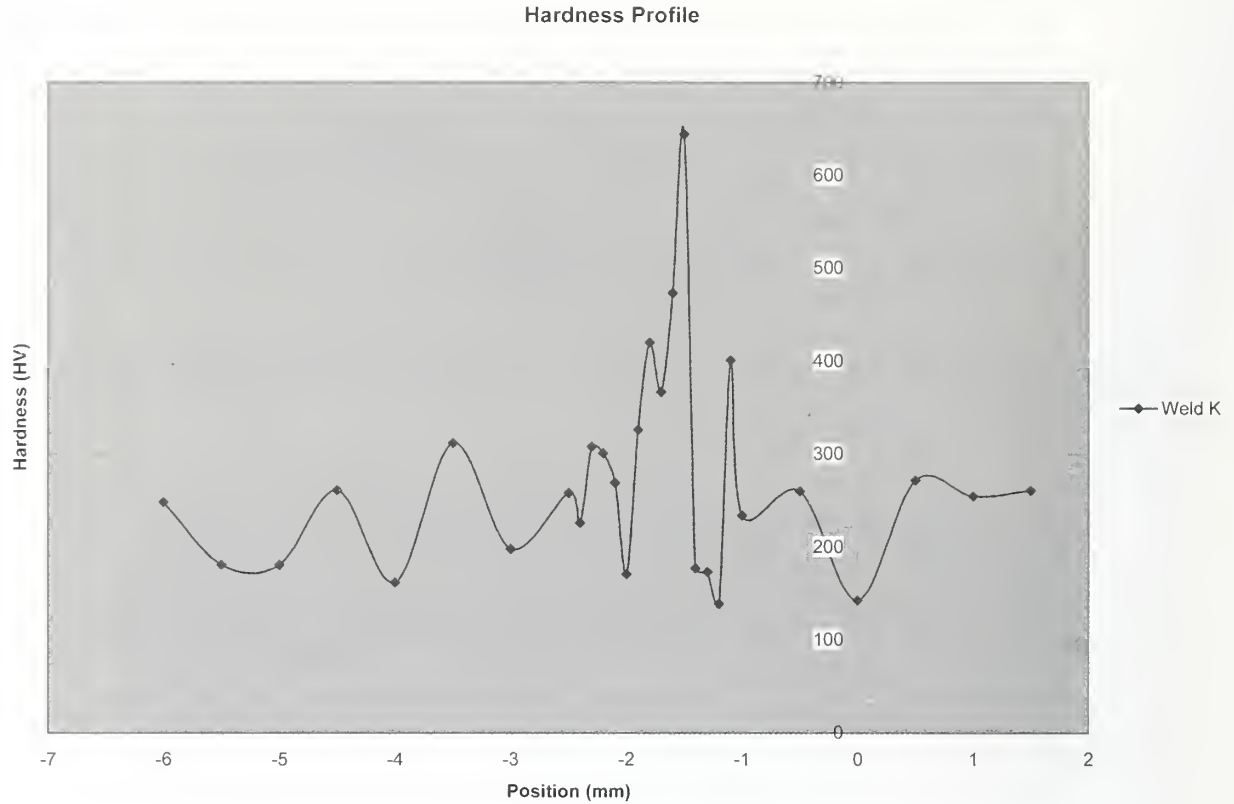
Figure 3. Vickers microhardness profile across the casting/weld interface for weld K. Negative position numbers indicate measurements in the casting, and positive numbers indicate measurements in the weld (PA-7). The region between 1 and 2 mm into the casting is where the heat from the application of the PA-7 hardened the microstructure, with several values above 400 HV. Between the fusion line and 1 mm into the casting, the hardness is lower, perhaps due to a slightly slower cooling rate. The hardness profile shows a hardness in the weld repair near 260 HV. This hardness is a reasonably good match to the hardness of the bulk casting.

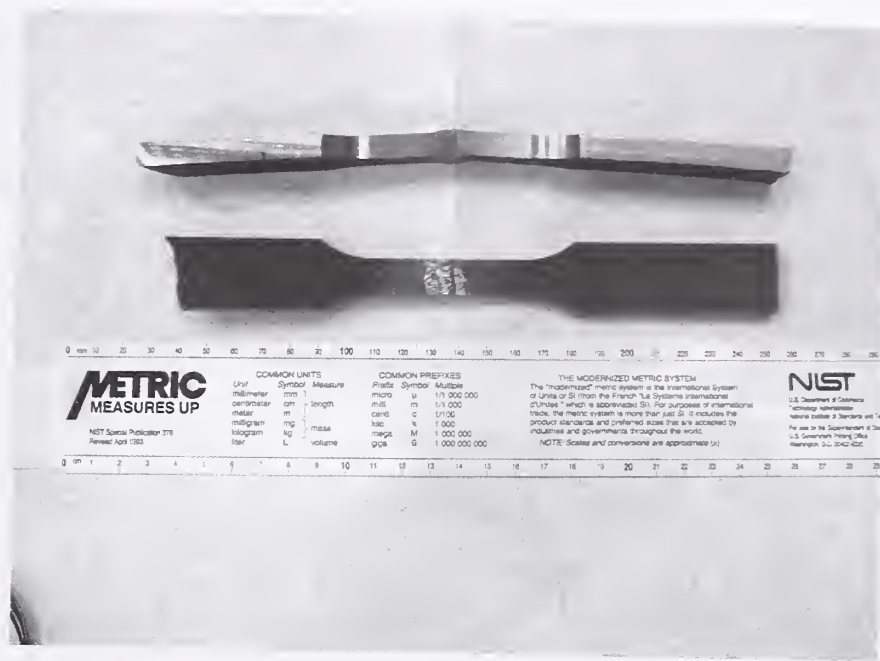
Figure 4. Photograph of a transverse tensile specimen made by TIG welding with a nickel-based composition. Notice the bend in the specimen at the weld caused by shrinkage stresses.

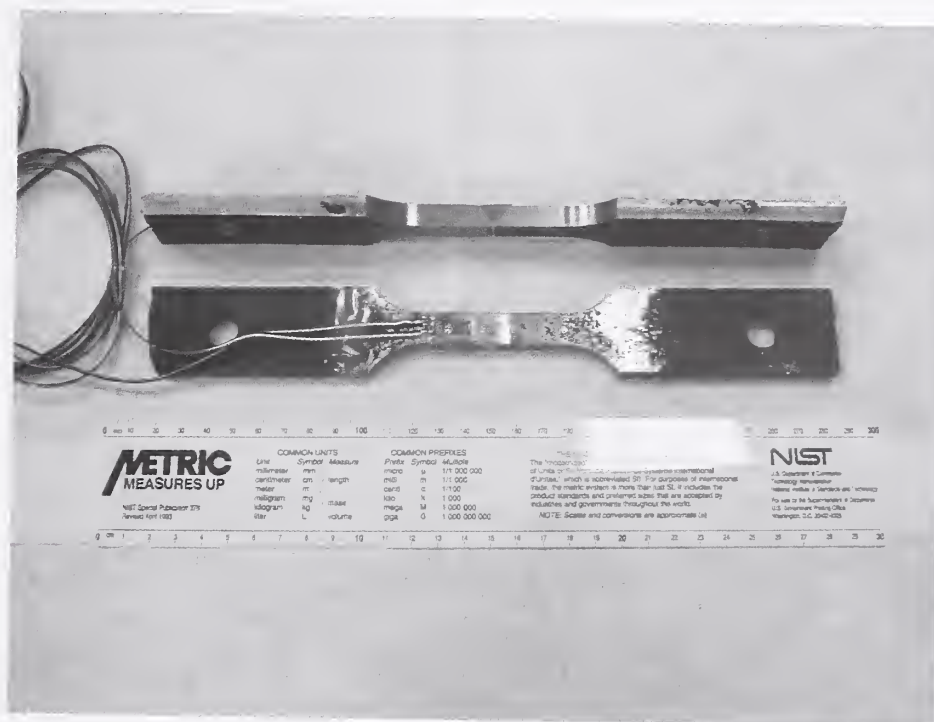
Figure 5. Photograph of a transverse tensile specimen made by oxyacetylene welding with low-fuming bronze. Notice the strain gages in the braze and the adjacent cast iron.

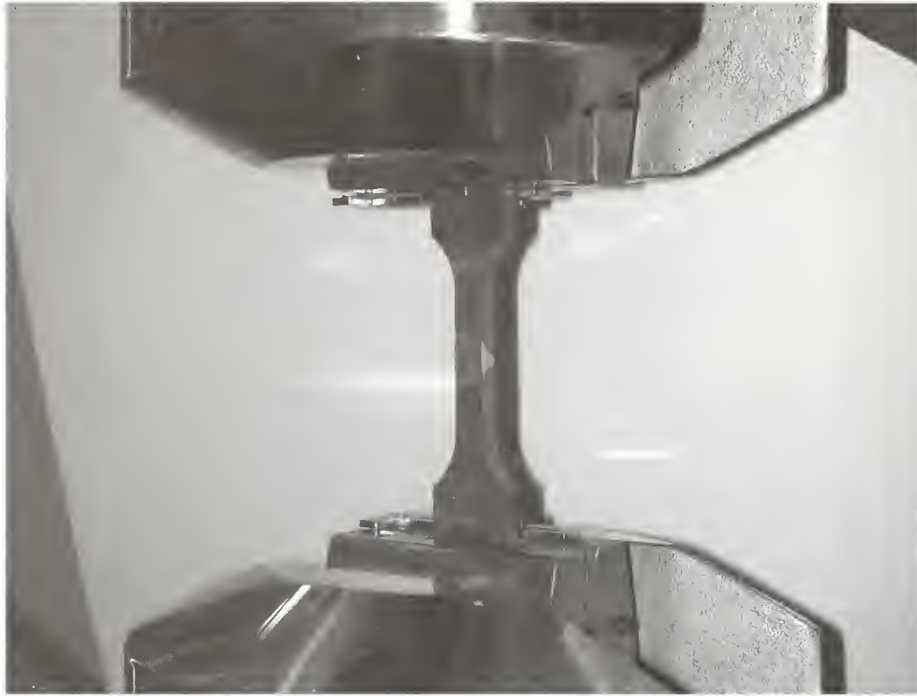
Figure 6. Tensile test fixture with low-fuming bronze specimen in place.

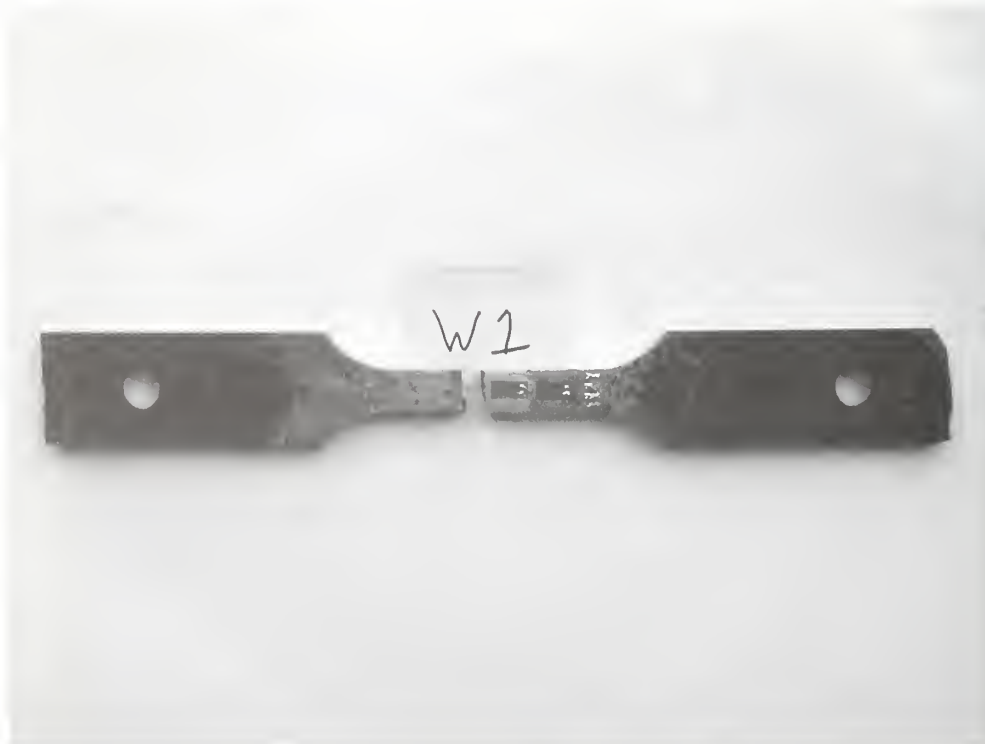
Figure 7. Fracture in tensile specimen (W) made with low-fuming bronze.

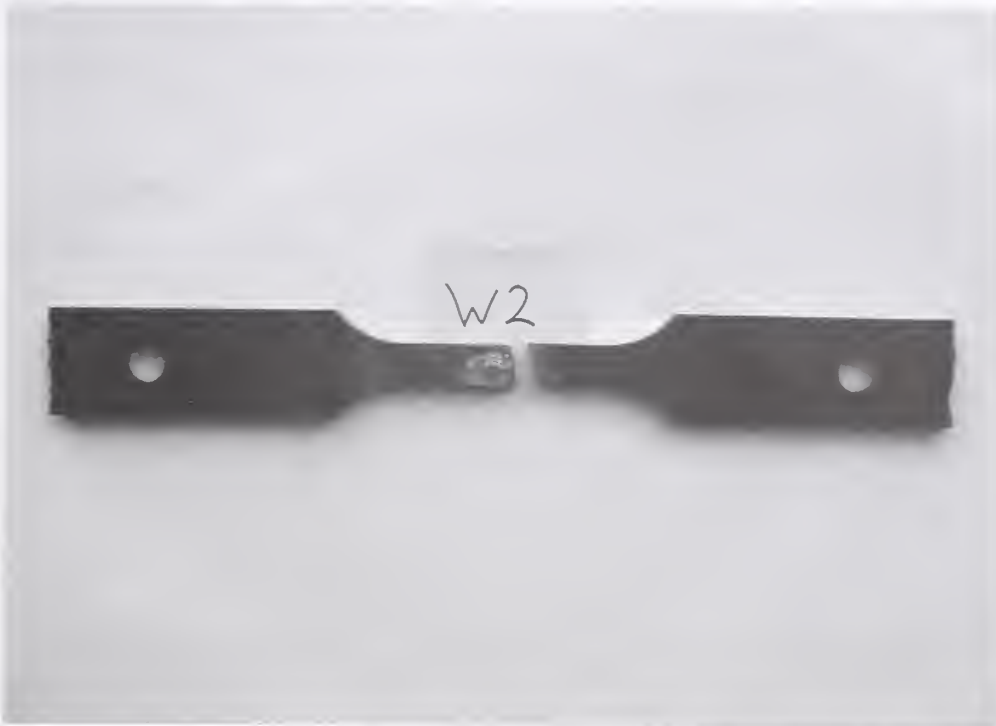
Figure 8. Fracture in tensile specimen (WM-2) made with low-fuming bronze.

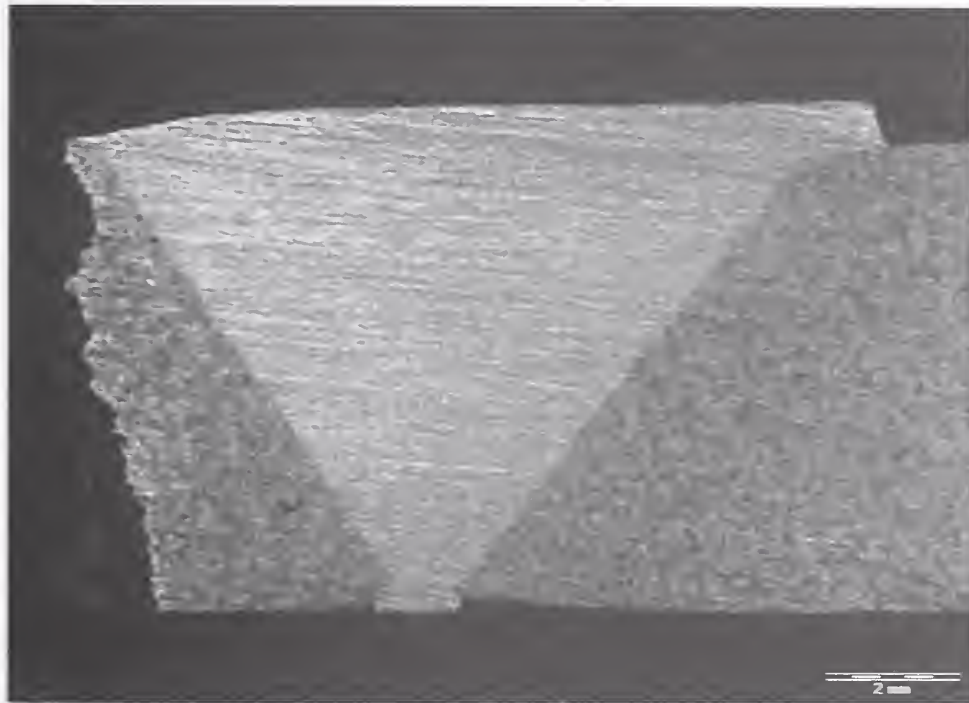
Figure 9. Cross section through specimen WM-2, showing the 75 ° included angle (10 X).

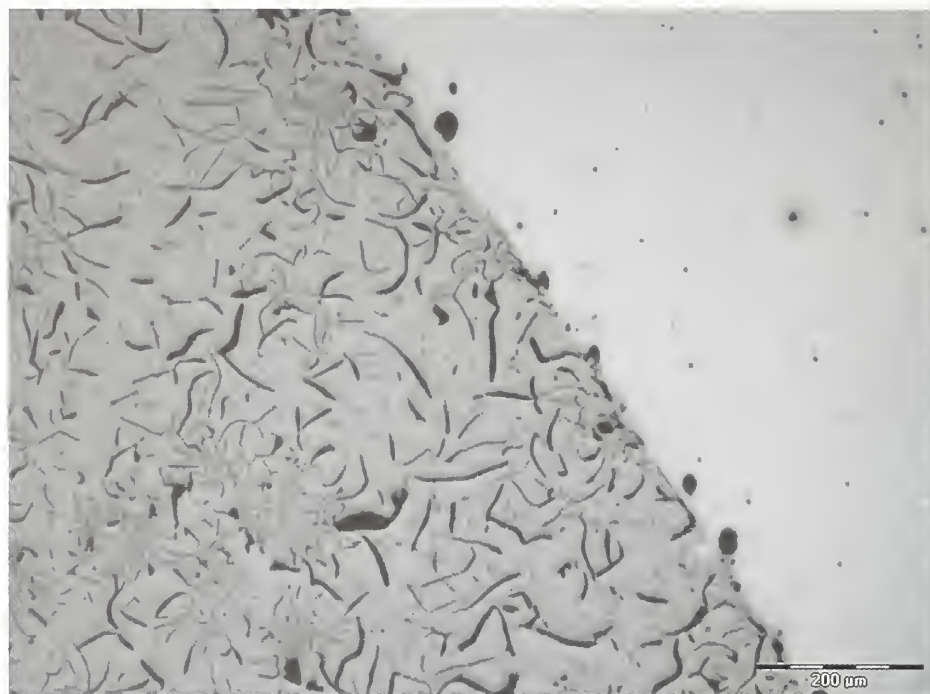
Figure 10. Higher magnification view of Figure 9 (~100 X), showing the interface between the cast iron (left) and the low-fuming bronze (right). Carbon flakes are visible in the cast iron.

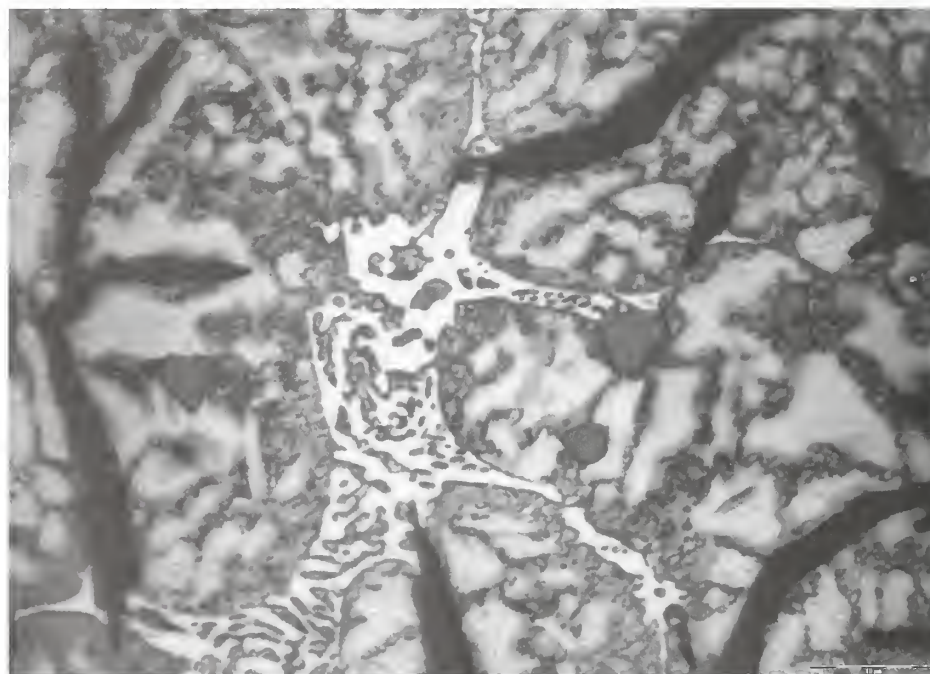
Figure 11. View at still higher magnification of the microstructure in the HAZ near the interface, now etched to show the other phases in the cast iron. These include iron phosphide islands (white) and spheroidized pearlite (brown) in the cast iron between the graphite flakes.

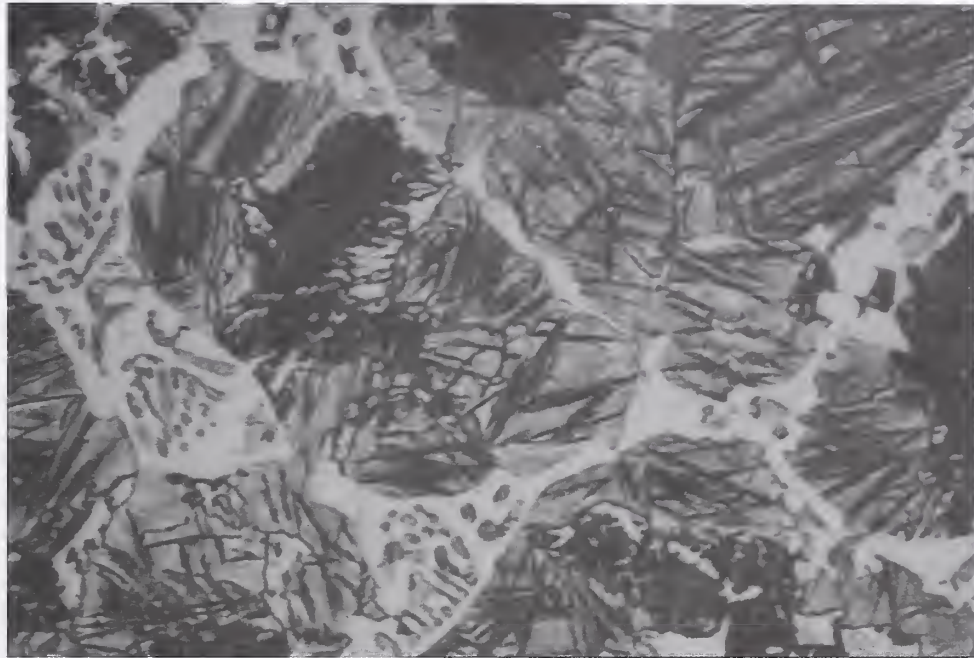
Figure 12. Martensite (black needles) in early braze weld that got too hot (~1000 X).

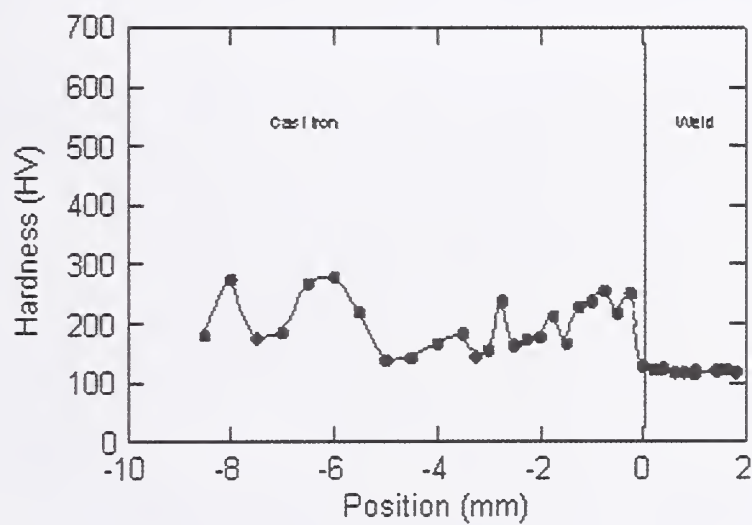
Figure 13. Hardness traverse across specimens WM-2, showing a much lower hardness (no martensite) in the HAZ than that for PA-7. Compare to Figure 3.

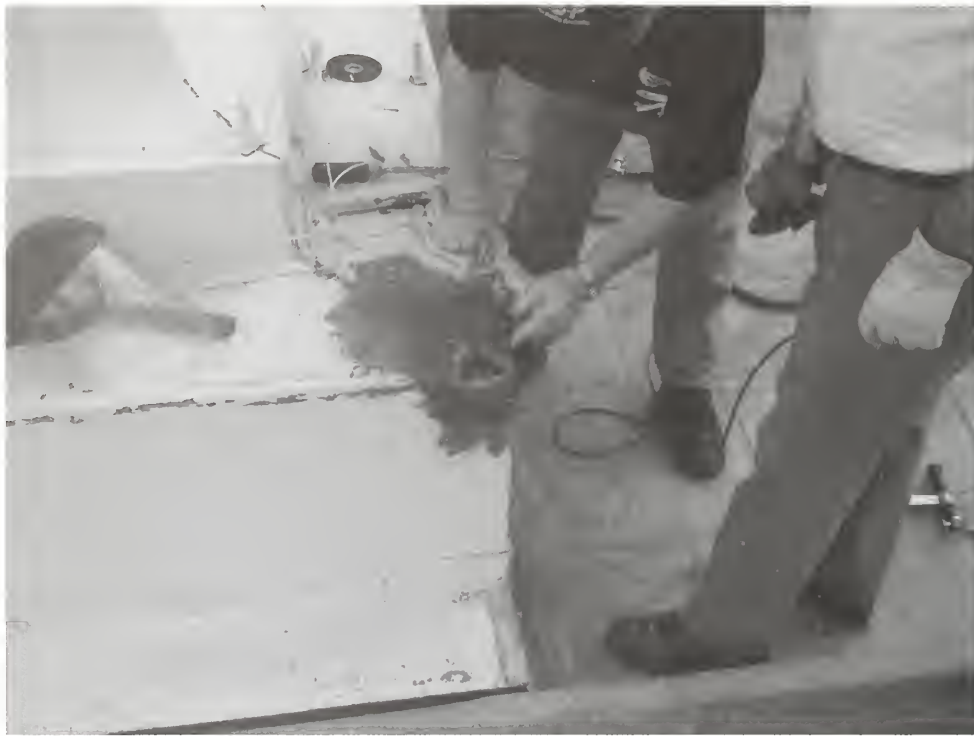
Figure 14. Repair Location 1: Two corners cracked free, flat orientation.

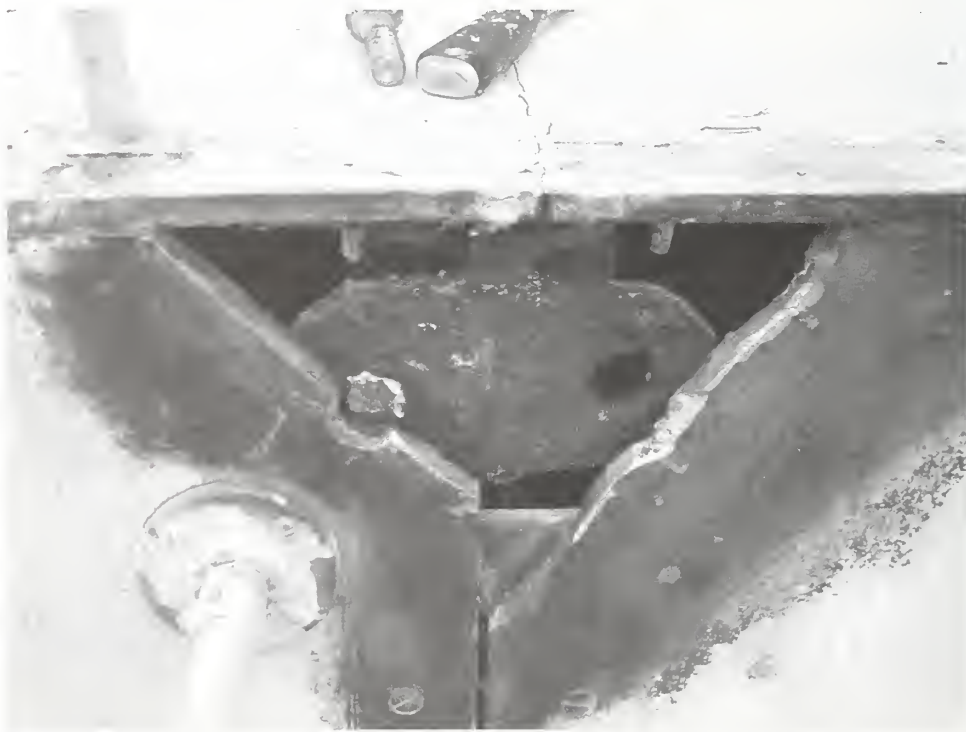
Figure 15. Repair Location 2: Two corners cracked free, vertical orientation.
